**Flood Control Project Maintenance
Levee Inspections**

Fall 2019 Levee Maintenance Deficiency Summary Report

**Flood Control Project Maintenance
Levee Inspections****LMA District Cover Sheet****Fall 2019 Levee Inspection Results****Reclamation District No. 0341 Sherman Island**

Reclamation District No. 0341 Sherman Island

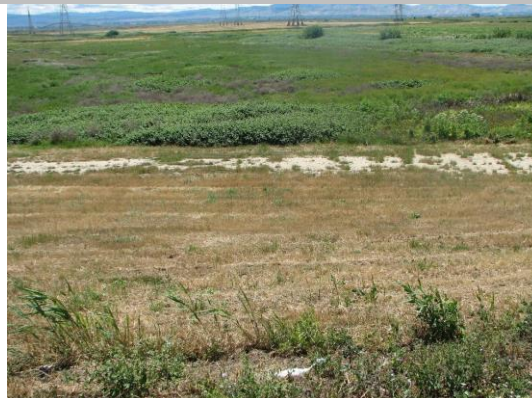
Photo 1 of 2 : UCIP_FA_2019_22262_37953.jpg

View of landward side no evidence of crossing.

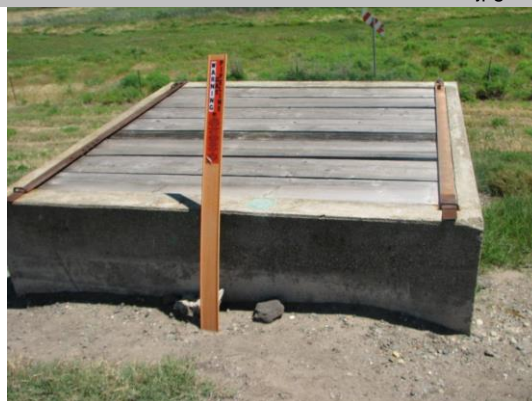
Photo 1 of 3 : UCIP_FA_2019_22263_37962.jpg

Comment Code						
Inspector Comment						
DS_ID:24081 FS_ID:22263 EP_NO: 892 Repair Type: Non-Urgent Crossing Status: Found UCIP Comments: Need to contact owner to determine status of crossing. Need date of last inspection and confirmation that crossing is still in operable condition. FIELD_STRUCT_DESC: 1 of 2: 12.75-inch steel gas line through the levee, 2.0 feet below the crown. Concrete cutoff wall around pipes at center of levee. Location marker on waterside (WS) slope. Concrete control box and valve pit on landside (LS) slope. Utility marker contact information includes Contact prior to Excavation call 1-800-227-2600 or Emergency Contact 1-800-811-4111. (12.75-inch gas line authorized under Permit No. 892, 1942 - Pacific Gas and Electric Company [PG&E]) [Additional Reference(s): DWR Levee Log, 1992. LMA encroachment station (STA) reference based on Map of Evacuation Route, Reclamation District 341 Sherman Island by Wagner Bonsignore Consulting Civil Engineers, A Corporation dated July 2012, STA 826+00] FS Date: 5/6/2009

View of landward side. Concrete box and markers indicating gas pipeline. Additional marker located at levee toe.

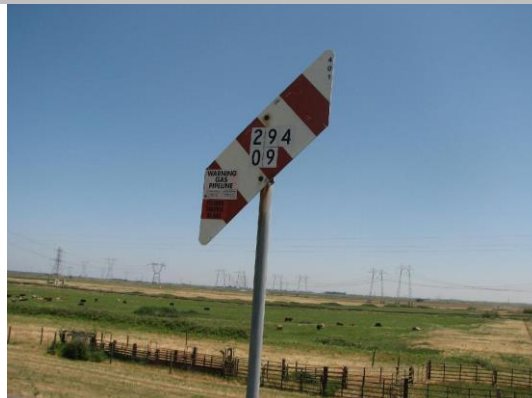
Photo 1 of 2 : UCIP_FA_2019_22267_37978.jpg

Comment Code					
Inspector Comment					
DS_ID:24193 FS_ID:22267 EP_NO: 15777 Repair Type: Non-Urgent Crossing Status: Indicator Found UCIP Comments: Need to contact owner to determine status of crossing. Need date of last inspection and confirmation that crossing is still in operable condition. Multiple crossings in general area need to clarify which pipes are in this levee section. FIELD_STRUCT_DESC: 42-inch steel natural gas line through the levee, bored 30-feet below the channel and both levees. Utility marker contact information includes Contact prior to Excavation call 1-800-227-2600 or Emergency Contact 1-800-811-4111. (42-inch line authorized under authorized Permit No. 15777, 1993 - PGT - PG&E Pipeline Expansion Project) [Additional Reference(s): LMA encroachment station (STA) reference based on Map of Evacuation Route, Reclamation District 341 Sherman Island by Wagner Bonsignore Consulting Civil Engineers, A Corporation dated July 2012, STA 826+00] FS Date: 5/6/2009

Marker located on landward side.

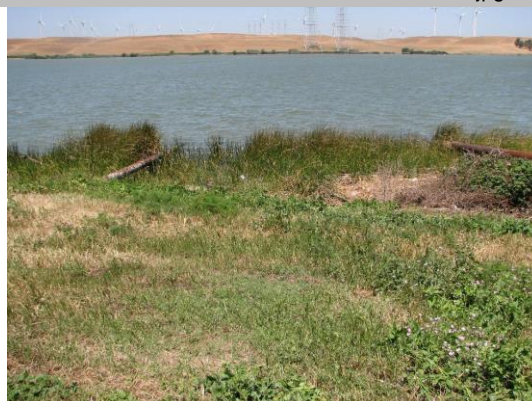
Photo 1 of 3 : UCIP_FA_2019_22293_38041.jpg

Comment Code					
Inspector Comment					
DS_ID:24128 FS_ID:22293 EP_NO: 1915 Repair Type: Non-Urgent Crossing Status: Found UCIP Comments: Will need to contact owner. Need to obtain maintenance records and clarify modifications made at to crossing (size). Also important to note that DWR DOE was out in the field during our pipe inspection they were conducting pipe evaluation for pipe replacement. Need to contact DWR DOE to determine location of pipe replacement. FIELD_STRUCT_DESC: 18-inch (not 12-inch as noted in historical records) steel irrigation pipe through the levee, 3.0 feet below the crown. 30-inch concrete standpipe riser on landside (LS). (Permit No. 1352-1948) Siphon breaker on landward side installed under Permit No. 1915 (1954). Pipe removed and replaced by 12-inch steel pipe under Permit No. 10799 (1977). (12-inch siphon pipe authorized under Permit No. 1352, 1948 - Celli Brothers; 12-inch pipe and 20-inch pipe approximately 4,900 feet and 9,400 feet downstream (D/S), respectively, from Emmaton authorized under Permit No. 1915, 1954 - Celli Brothers; 12-inch pipe authorized to replace existing 12-inch pipe under Permit No. 10799, 1977 - Gene Celli) [Additional Reference(s): DWR Levee Log, 1992. LMA encroachment station (STA) reference based on Map of Evacuation Route, Reclamation District 341 Sherman Island by Wagner Bonsignore Consulting Civil Engineers, A Corporation dated July 2012, STA 799+00] FS Date: 5/6/2009

Overview of waterward side-18-inch pipe located on right side and 12-inch pipe located on left side.

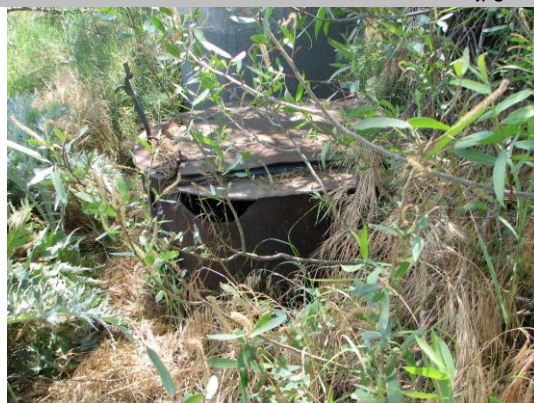
Photo 3 of 3 : UCIP_FA_2019_22294_38047.jpg

Comment Code						
Inspector Comment						
DS_ID:24243 FS_ID:22294 EP_NO: 10799 Repair Type: Non-Urgent Crossing Status: Found UCIP Comments: Will need to contact owner. Need to obtain maintenance records and clarify modifications made at to crossing (size). Also important to note that DWR DOE was out in the field during our pipe inspection they were conducting pipe evaluation for pipe replacement. Need to contact DWR DOE to determine location of pipe replacement. FIELD_STRUCT_DESC: 12-inch steel irrigation pipe through the levee, 5.3 feet below the crown. Steel cutoff wall around pipe at center of levee. Siphon breaker on landside (LS) shoulder. Steel (not concrete as mentioned in historical records) pipe riser on the LS. 2-inch pipe sleeve around pipe at waterside (WS) shoulder. Rock revetment on WS slope. Pipe exposed along WS slope. (12-inch pipe authorized under Permit No. 10799, 1977 - G. Celli) [Additional Reference(s): DWR Levee Log, 1992. LMA encroachment station (STA) reference based on Map of Evacuation Route, Reclamation District 341 Sherman Island by Wagner Bonsignore Consulting Civil Engineers, A Corporation dated July 2012, STA 799+00] FS Date: 5/6/2009

Steel stand pipe located on landward side near levee toe.

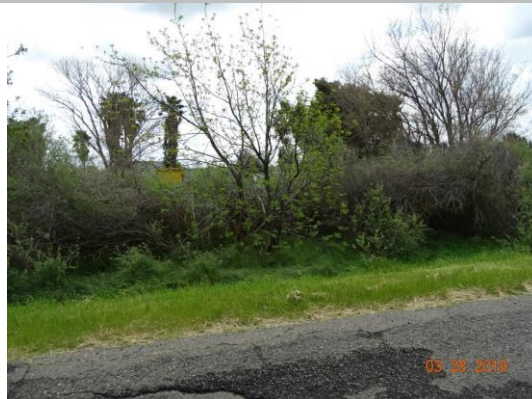
Photo 1 of 1 : FA_2019_RD0341_168_51_20190826_00017.jpg

LM Start	7.78	Rating **	U	Issue No.	51
LM End	7.78	Issue Type +	En	Location *	LS
Category	Earthen Levee			GPS Latitude/Longitude	
				Start	End
Item	Vegetation			38.075008 °	38.075008 °
				-121.755815 °	-121.755815 °
DWR ID	DWR_RD0341_02_s_2019_51				
Comment Code					
V6 : Landscaping					
Inspector Comment

View looking downslope at landscaping on the landside slope (Spring 2019).

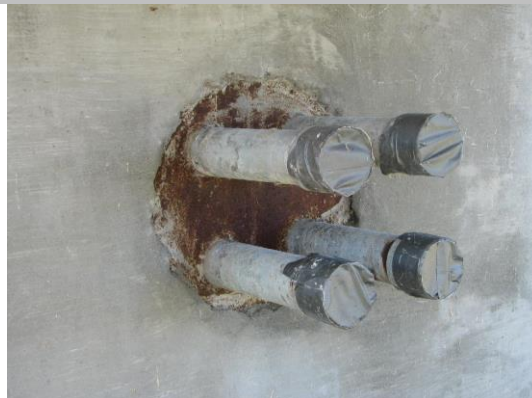
Photo 2 of 3 : UCIP_FA_2019_22303_38061.jpg

Comment Code						
Inspector Comment						
DS_ID:24246 FS_ID:22303 EP_NO: N/A Repair Type: Non-Urgent Crossing Status: Found UCIP Comments: Need to determine the status of conduit--has construction been completed? FIELD_STRUCT_DESC: Four 2.5-inch conduits sleeved through 12-inch steel pipe through the levee at an unknown depth below the levee crown. Boat launching dock and ramp are located on the waterside (WS). [Additional Reference(s): LMA encroachment station (STA) reference based on Map of Evacuation Route, Reclamation District 341 Sherman Island by Wagner Bonsignore Consulting Civil Engineers, A Corporation dated July 2012, STA 778+00] FS Date: 5/6/2009

Conduits exposed on waterward side.

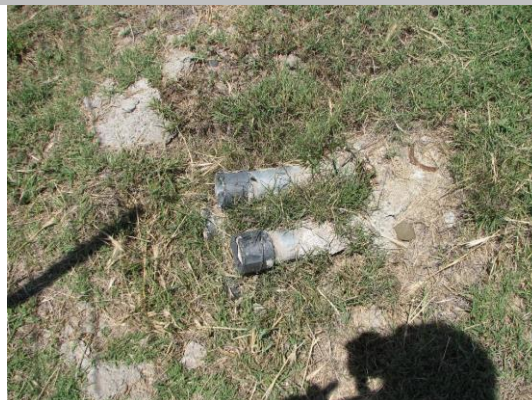
Photo 3 of 3 : UCIP_FA_2019_22303_38060.jpg

View of conduit on landward side. Four 2.5-inch conduits through levee not in use yet.

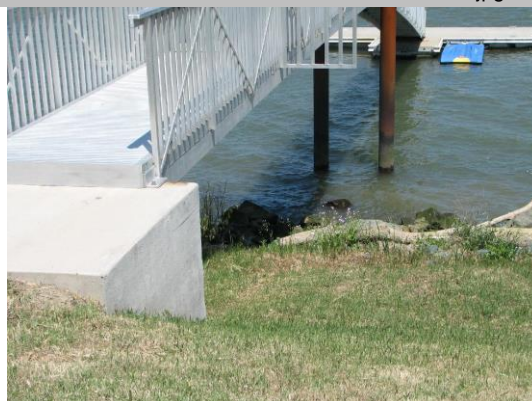
Photo 1 of 1 : UCIP_FA_2019_22305_38064.jpg

Comment Code					
Inspector Comment					
DS_ID:24221 FS_ID:22305 EP_NO: 17728 Repair Type: Non-Urgent Crossing Status: Not Found UCIP Comments: Need to clarify if three 2-inch steel conduits were installed. This permit appears to be associated with the dock installed at levee mile 7.91. See inspection sheet for LM 7.91. FIELD_STRUCT_DESC: Three 2-inch steel electric conduits encased in a single 6-inch steel conduit through the levee, 2.0 feet below the levee crown. Gaps filled with grout. Boat dock (60-foot by 8-foot) and landing on steel pilings in the channel. Metal bridge, concrete landing on pilings and foot paths on the waterside (WS) slope. Rock revetment on WS slope. (6-inch conduit authorized under Permit No. 17728, 2004 - T. Demattei) [Additional Reference(s): LMA encroachment station (STA) reference based on Map of Evacuation Route, Reclamation District 341 Sherman Island by Wagner Bonsignore Consulting Civil Engineers, A Corporation dated July 2012, STA 764+00] FS Date: 5/6/2009

Dock installed at levee mile 7.91.

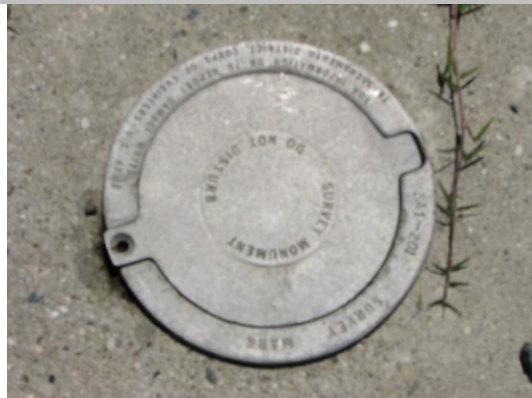
Photo 1 of 3 : UCIP_FA_2019_22306_38067.jpg

Comment Code						
Inspector Comment						
DS_ID:24130 FS_ID:22306 EP_NO: 3494 Repair Type: Non-Urgent Crossing Status: Indicator Found UCIP Comments: Need to contact owner to determine status of crossing. Need date of last inspection and confirmation that crossing is still in operable condition. FIELD_STRUCT_DESC: 1 of 2: 26-inch concrete encased steel gas line through the levee, 5.1 feet below the crown. Concrete cutoff wall around pipe at center of levee. Location sign on waterward shoulder. Rock revetment on waterward slope. Contact number listed on marker out in the field 1-800-811-4111. (two 26-inch lines authorized under Permit No. 3494, 1961 - Pacific Gas and Electric Company [PG&E]) [Additional Reference(s): DWR Levee Log, 1992. [LMA encroachment station (STA) reference based on Map of Evacuation Route, Reclamation District 341 Sherman Island by Wagner Bonsignore Consulting Civil Engineers, A Corporation dated July 2012, STA 756+00] FS Date: 5/6/2009

Survey marker found at this location.

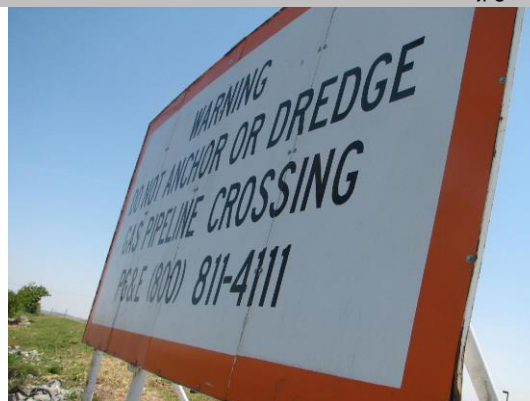
Photo 3 of 3 : UCIP_FA_2019_22306_38065.jpg

Comment Code						
Inspector Comment						
DS_ID:24130 FS_ID:22306 EP_NO: 3494 Repair Type: Non-Urgent Crossing Status: Indicator Found UCIP Comments: Need to contact owner to determine status of crossing. Need date of last inspection and confirmation that crossing is still in operable condition. FIELD_STRUCT_DESC: 1 of 2: 26-inch concrete encased steel gas line through the levee, 5.1 feet below the crown. Concrete cutoff wall around pipe at center of levee. Location sign on waterward shoulder. Rock revetment on waterward slope. Contact number listed on marker out in the field 1-800-811-4111. (two 26-inch lines authorized under Permit No. 3494, 1961 - Pacific Gas and Electric Company [PG&E]) [Additional Reference(s): DWR Levee Log, 1992. [LMA encroachment station (STA) reference based on Map of Evacuation Route, Reclamation District 341 Sherman Island by Wagner Bonsignore Consulting Civil Engineers, A Corporation dated July 2012, STA 756+00] FS Date: 5/6/2009

Gas line crossing sign located on waterward side.

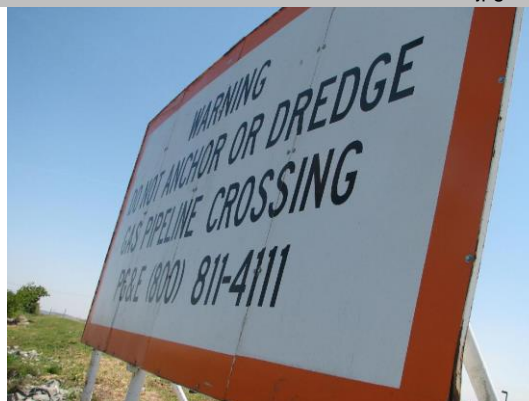
Photo 3 of 3 : UCIP_FA_2019_22307_38068.jpg

Comment Code						
Inspector Comment						
DS_ID:24233 FS_ID:22307 EP_NO: 3494 Repair Type: Non-Urgent Crossing Status: Indicator Found UCIP Comments: Need to contact owner to determine status of crossing. Need date of last inspection and confirmation that crossing is still in operable condition. FIELD_STRUCT_DESC: 2 of 2: 26-inch concrete encased steel gas line through the levee, 5.1 feet below the crown. Concrete cutoff wall around pipe at center of levee. Location sign on waterward shoulder. Rock revetment on waterward slope. Contact number provided on marker out in the field 1-800-811-4111. (two 26-inch lines authorized under Permit No. 3494, 1961 - Pacific Gas and Electric Company [PG&E]) [Additional Reference(s): DWR Levee Log, 1992. LMA encroachment station (STA) reference based on Map of Evacuation Route, Reclamation District 341 Sherman Island by Wagner Bonsignore Consulting Civil Engineers, A Corporation dated July 2012, STA 756+00] FS Date: 5/6/2009

Gas line crossing sign located on waterward side.

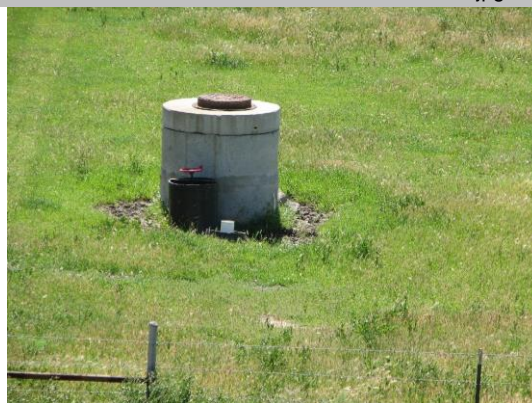
Photo 1 of 3 : UCIP_FA_2019_22309_38075.jpg

Concrete stand pipe and gate valve located on landward side.

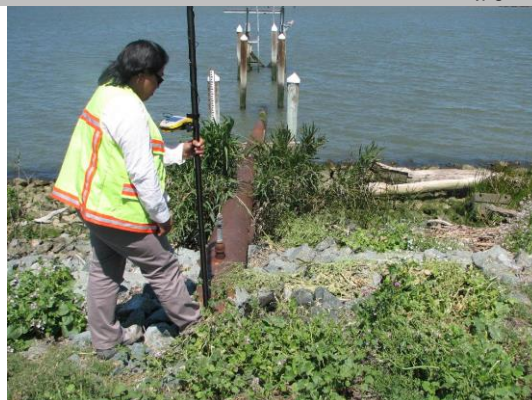
Photo 2 of 3 : UCIP_FA_2019_22309_38076.jpg

Overview of crossing on waterward side.

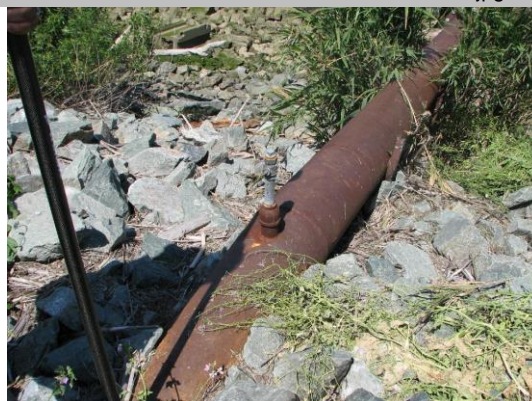
Photo 3 of 3 : UCIP_FA_2019_22309_38077.jpg

Comment Code						
Inspector Comment						
DS_ID:24247 FS_ID:22309 EP_NO: N/A Repair Type: Non-Urgent Crossing Status: Found UCIP Comments: 7/6/2016 Meet with Joel McElroy, District Representative, at site. DWR Bay Delta Division owns pipe. Pipe is active. Need to contact owner to determine permit authorizing pipe crossing. (DWR UCIP - O. Magana) 05/06/2009 New record found in the field. Unable to find any information for crossing during DWR desk study. Will need to find the owner and obtain records for crossing. Need to coordinate with CVFPB. (DWR UCIP - O. Magana) FIELD_STRUCT_DESC: 10-inch steel irrigation pipe through the levee, at a shallow depth below the crown. Air vent on the waterside (WS). Distribution box with slide gate and observation well on the landside (LS). Pumping station on the LS. Rip rap located on WS. [Additional Reference(s): LMA encroachment station (STA) reference based on Map of Evacuation Route, Reclamation District 341 Sherman Island by Wagner Bonsignore Consulting Civil Engineers, A Corporation dated July 2012, STA 751+00] FS Date: 5/6/2009

Siphon breaker visible on waterward side. Levee toe is armored with rock slope protection.

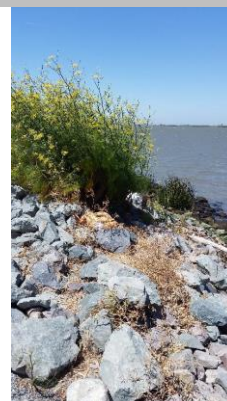
Photo 1 of 3 : UCIP_FA_2019_50082_75941.jpg

View of WS.

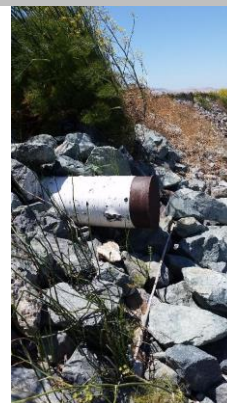
Photo 2 of 3 : UCIP_FA_2019_50082_75942.jpg

New pipe(non-functional) metal plate installed on the WS.

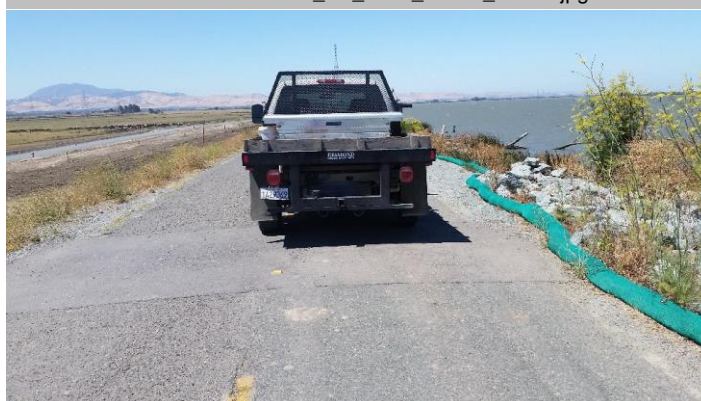
Photo 3 of 3 : UCIP_FA_2019_50082_75943.jpg

Comment Code						
Inspector Comment						
DS_ID:25470 FS_ID:50082 EP_NO: N/A Repair Type: Non-Urgent Crossing Status: Found UCIP Comments: 7/6/2016 Pipe found in 2009 has been removed and new pipe installed. Unable to determine permit authorizing work. Need to coordinate with owner to obtain details regarding permit and pipe install. (DWR UCIP - omagana) FIELD_STRUCT_DESC: UNK size pipe through the levee. (unknown permit authorizing work; previous 10-inch pipe removed between 2009-2016, 10-inch pipe authorized under Automatic Board Order (ABO) issued as Permit No. 11108, 1975 - D. Faria) [Additional Reference(s): LMA encroachment station (STA) reference based on Map of Evacuation Route, Reclamation District 341 Sherman Island by Wagner Bonsignore Consulting Civil Engineers, A Corporation dated July 2012, STA 743+00] FS Date: 7/6/2016

View of levee crown.

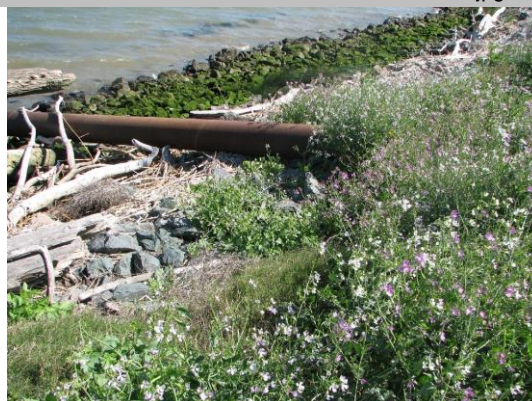
Photo 1 of 3 : UCIP_FA_2019_22324_38096.jpg

Overview of waterward side.

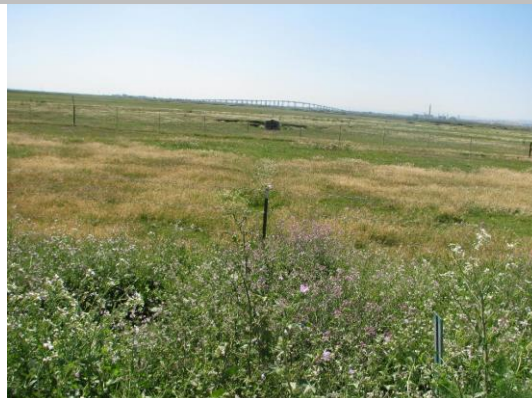
Photo 3 of 3 : UCIP_FA_2019_22324_38094.jpg

Comment Code						
Inspector Comment						
DS_ID:24133 FS_ID:22324 EP_NO: 11114 Repair Type: Non-Urgent Crossing Status: Found UCIP Comments: 7/6/2016 Meet with Joel McElroy, District Representative, at site. DWR Bay Delta Division owns pipe. Need to contact owner to determine status of pipe crossing. (DWR UCIP - O. Magana) 05/06/2009 Dense vegetation limits the inspector's visibility to identify signs of pipe failure (leaks) along the slope. Recommend removing vegetation along pipe alignment to conduct proper inspection of structure and appurtenances. (DWR UCIP - O. Magana) FIELD_STRUCT_DESC: 14-inch steel pipe of unknown purpose through the levee, 4.0 feet below the levee crown. Concrete standpipe with slide gate located on the landside (LS). Rock revetment on the waterside (WS) slope. (14-inch pipe retained under Automatic Board Order (ABO) issued as Permit No. 11114, 1975 - E. J. Trigueiro) [Additional Reference(s): DWR Levee Log, 1992. LMA encroachment station (STA) reference based on Map of Evacuation Route, Reclamation District 341 Sherman Island by Wagner Bonsignore Consulting Civil Engineers, A Corporation dated July 2012, STA 720+00] FS Date: 5/6/2009

Overview of landward side.
